The above wall and photos are from a bus depot workshop in the Sydney suburb of Burwood. It appeared the wall had rotated (at the damp proof course) and had some cracking. The wall was over 60 metres in length and was over 8 metres in height. It was assessed by a structural engineer, and it was noted the wall did not have any expansion joints (which was normal considering the era it was constructed). And due to this, during normal expansion and contraction of bricks and mortar due to temperature variances, the forces exerted were too strong especially due to sheer length and height of the wall. It was recommended expansion joints be introduced at intervals. This resulted in cutting the wall vertically and placing the correct expansion material.

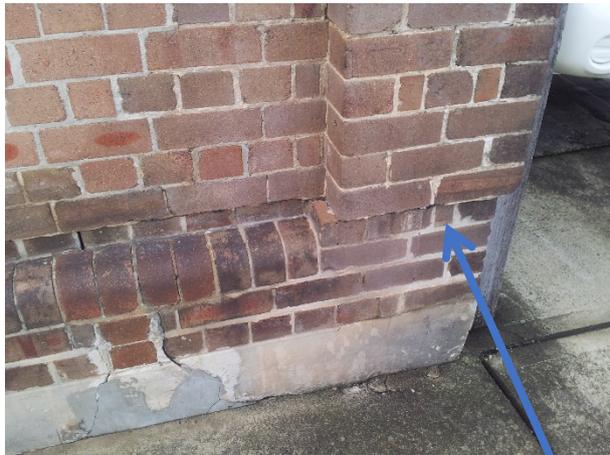
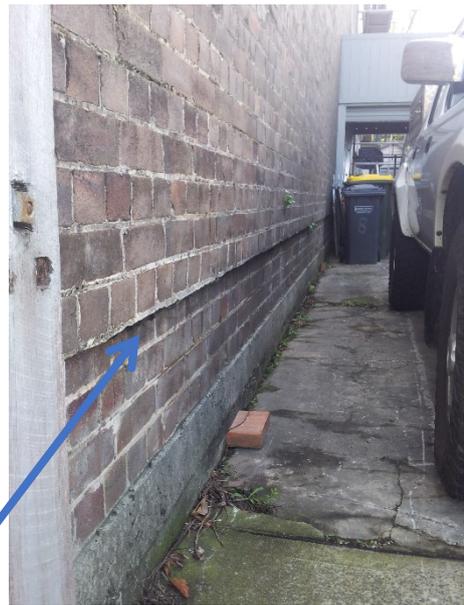
Wall had rotated at the damp proof course.

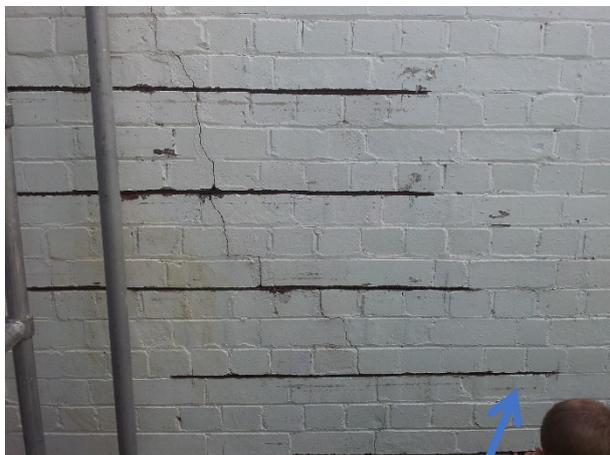
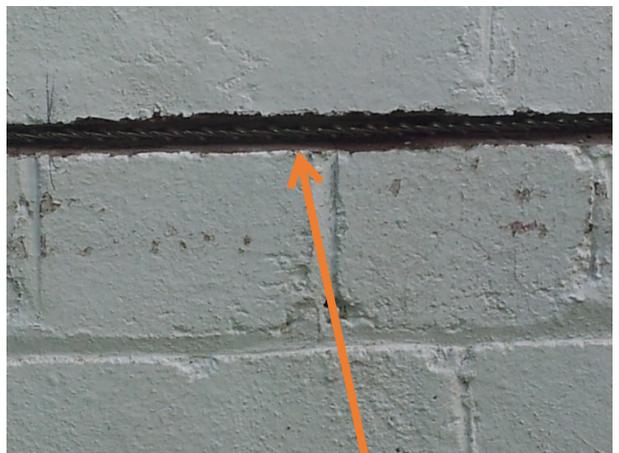
Wall cracking repaired using a proprietary product (Helifix)

In addition, all cracking had to be repaired. This was completed using a proprietary product (Helifix). This was completed by cutting horizontally through the mortar every three brick courses and installing a stain steel tie bar and placing the proprietary mortar product back in.
