Slope Collapse

### Slope Collapse and Retaining Wall Installation

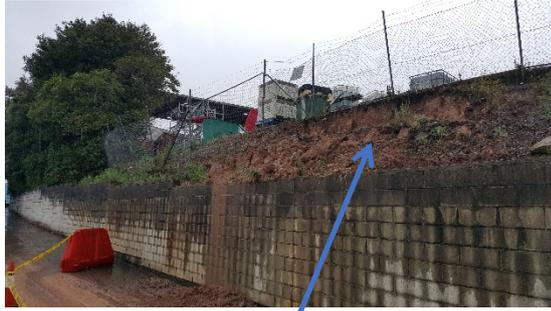
This slope collapse occurred at an operational bus depot at the Sydney suburb of Ryde. The slope collapse occurred due to heavy and consistent rainfall in the preceding days. Also, the slope had minimal vegetation cover. We were advised several years earlier; the slope was rich in trees, but they were removed. The collapse of the slope also exposed utilities in the area. This included electrical, communications, and a fire hydrant. The utilities were strapped to Deadman anchors to avoid collapse of the conduits as they were suspended in the air, till the new retaining wall could be constructed. The slope itself was stabilised by utilising one tonne sandbags, and geotextile fabric.

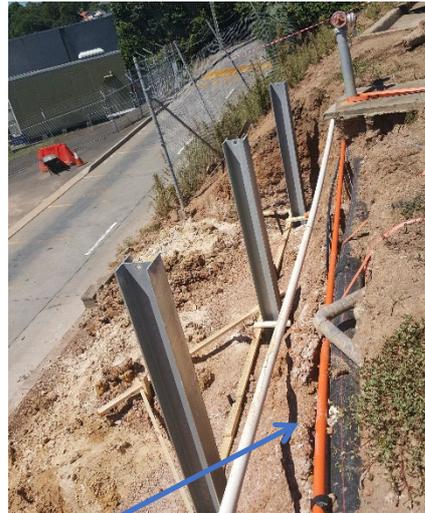
The collapse exposed utilities in the area, including electrical, communications, and fire hydrant.

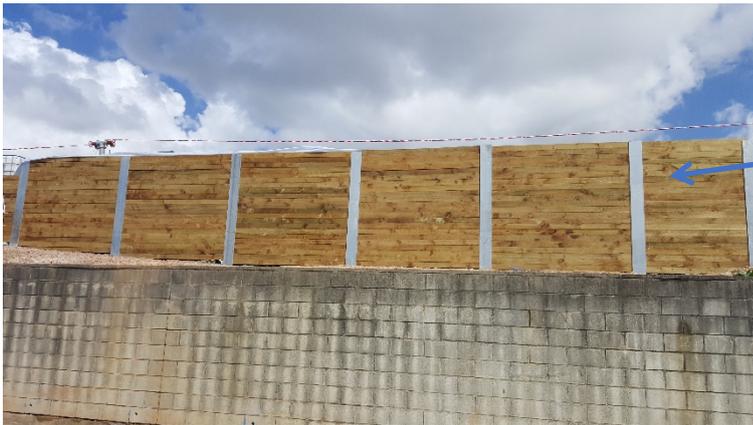
A retaining wall consisting of H columns and timber sleepers was utilised to repair the slope.

To expedite the design, both standard universal columns and treated pine sleepers were chosen, and their availability confirmed with suppliers. The columns themselves were utilised in the piles, rather than having reinforcement and a rag bolt assembly to attach the columns to. This simplified the construction process. Whilst we had existing bore log details and geotechnical information for the area, we also ensured a geotechnical engineer was available on site ensuring the piles socketed into rock.

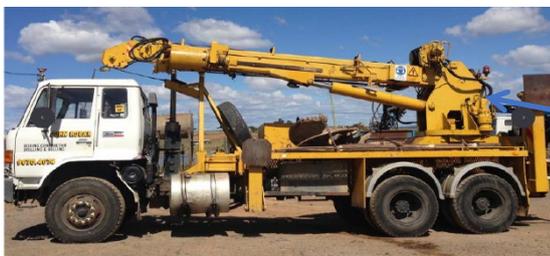
A piling rig for tight access applications was used to bore the piles. This allows piles to be bored from a surface not level with the pile finish level. (i.e. the plant item can site below or above the finish surface level of the piles, which is not achievable utilising a normal piling rig).

To bore the piles, a non-standard auger was utilised. This auger was a mobile unit which is attached to a truck. It is versatile for hard to reach applications. The piles don't have to be drilled from the surface finish level. They can be drilled from either below or above the finished surface. Whilst a long reach excavator was considered, it was ruled out due to access issues. Please refer above for photos.
